Contract #: 04-0120F4Cty: SF/ALA Rte: 80 PM: 13.2/13.9File #: 69.28**WELDING INSPECTION REPORT****Resident Engineer:**Pursell, Gary**Address:** 333 Burma Road**City:** Oakland, CA 94607**Report No:** WIR-003504**Date Inspected:** 10-Jul-2008**Project Name:** SAS Superstructure**OSM Arrival Time:** 2230**Prime Contractor:** American Bridge/Fluor Enterprises, a JV**OSM Departure Time:** 730**Contractor:** Zhenhua Port Machinery Company, Ltd (ZPMC), Changxing Island **Location:** Shanghai, China**CWI Name:** N/A**CWI Present:** Yes No**Inspected CWI report:** Yes No N/A**Rod Oven in Use:** Yes No N/A**Electrode to specification:** Yes No N/A**Weld Procedures Followed:** Yes No N/A**Qualified Welders:** Yes No N/A**Verified Joint Fit-up:** Yes No N/A**Approved Drawings:** Yes No N/A**Approved WPS:** Yes No N/A**Delayed / Cancelled:** Yes No N/A**Bridge No:** 34-0006**Component:** OBG Fabrication**Summary of Items Observed:**

Orthotropic Box Girder (OBG) Fabrication:

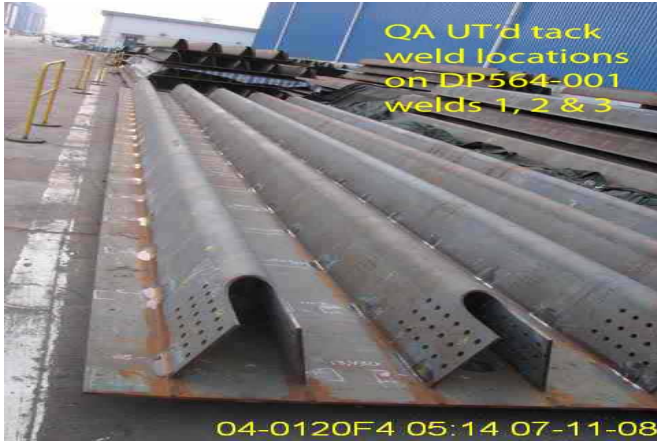
The QA Inspector performed ultrasonic inspections of deck plate DP564-001 welds #001, #002 and #003 to determine the amount of weld penetration in the locations where tack welds had been located. Caltrans QA had previously identified some of these tack welds appeared to have crack like indications and ZPMC completed welding prior to verification that the cracks had been removed. Each of the welds had approximately 25 tack welds and a total of 75 locations were ultrasonically inspected this shift. The QA Inspector observed lack of fusion varied between 1.7 mm and 4.4 mm. The results of these inspections were submitted to Caltrans QA task leader Mr. Dave McClary.
